## Lake Study Report Silver Lake – Portage, Wisconsin WBIC #107700

Final Report  
to Columbia County, City of Portage and  
Wisconsin Department of Natural Resources

R. Haney & P. McGinley

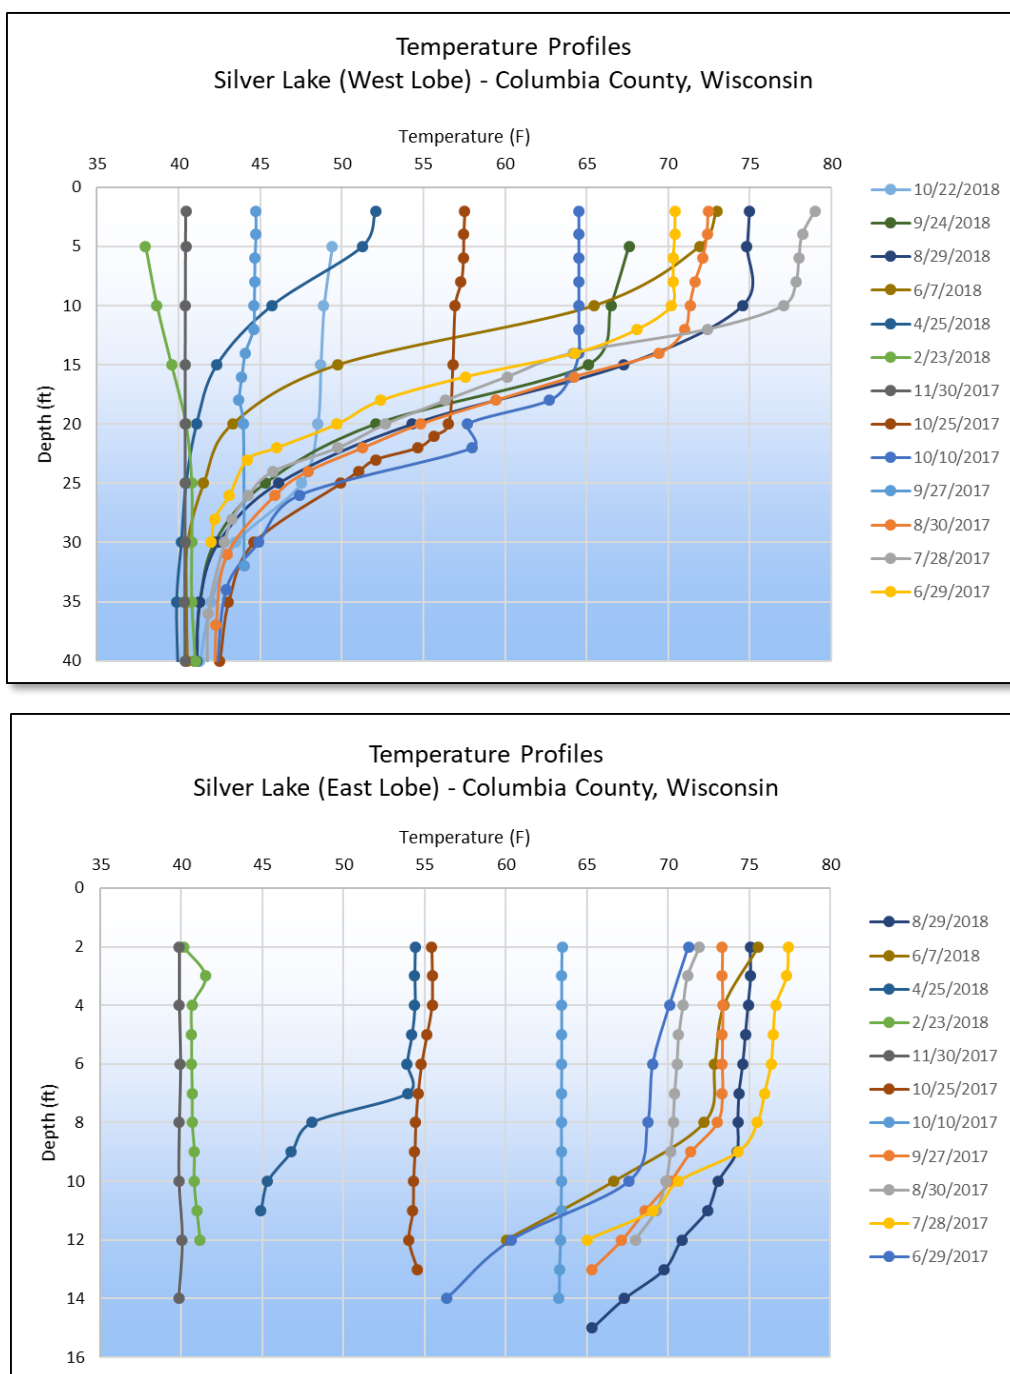
FIGURE 8. TEMPERATURE PROFILES IN SILVER LAKE, 2017-2019.

In a lake, the water temperature changes throughout the year and may vary with depth. Water temperature was measured in each basin of Silver Lake from the surface to the bottom at the time of sample collection (Figure 8). During the 2017-2019 study, temperature data illustrated a typical deep lake profile in the west basin with a well-developed thermocline by June between 15 and 25 feet. Spring and fall overturn profiles are apparent with temperatures between 37 and 42 degrees maintained with depth. The east basin illustrates typical profiles of a shallow, mixed lake that maintain a similar temperature from surface to bottom. During the summer months, a period of slight stratification develops as surface temperatures warm.

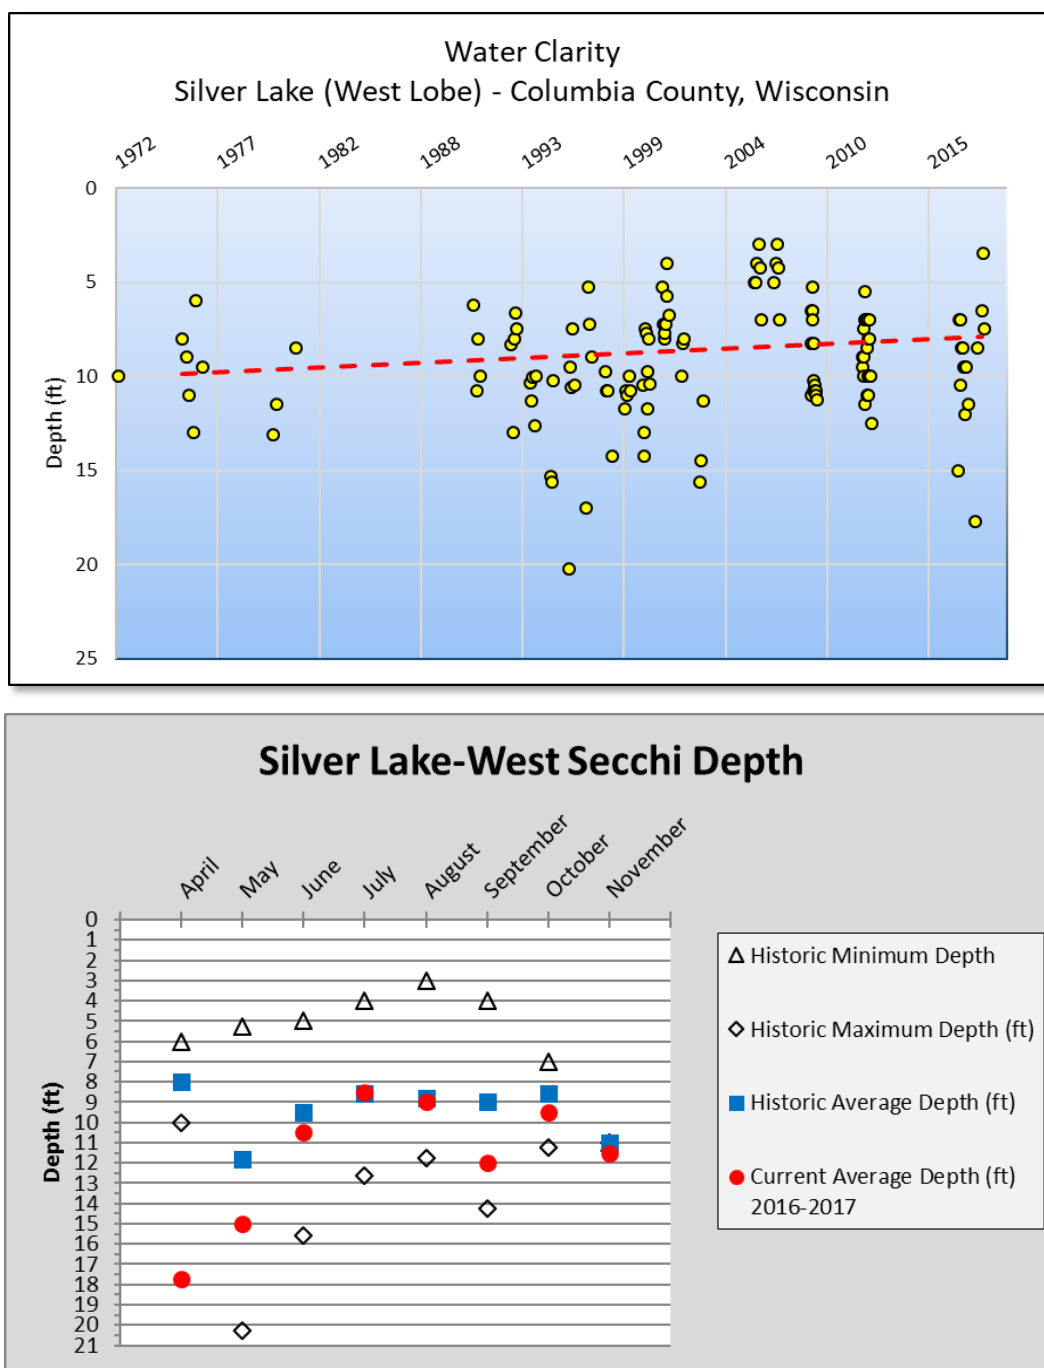
FIGURE 10. WATER CLARITY IN SILVER LAKE-WEST.

The west basin, which generally has slightly deeper secchi depths than the east basin, observed depths ranging from 7 feet to 17.7 feet during the study (Figure 10) and shows a decreasing trend over the long term (based on July/August data). When compared with past data as far back as the early 1970s, the average water clarity measured during the study was similar in all sampled months except. Water clarity in Silver Lake was typically reduced during the late summer and early fall.

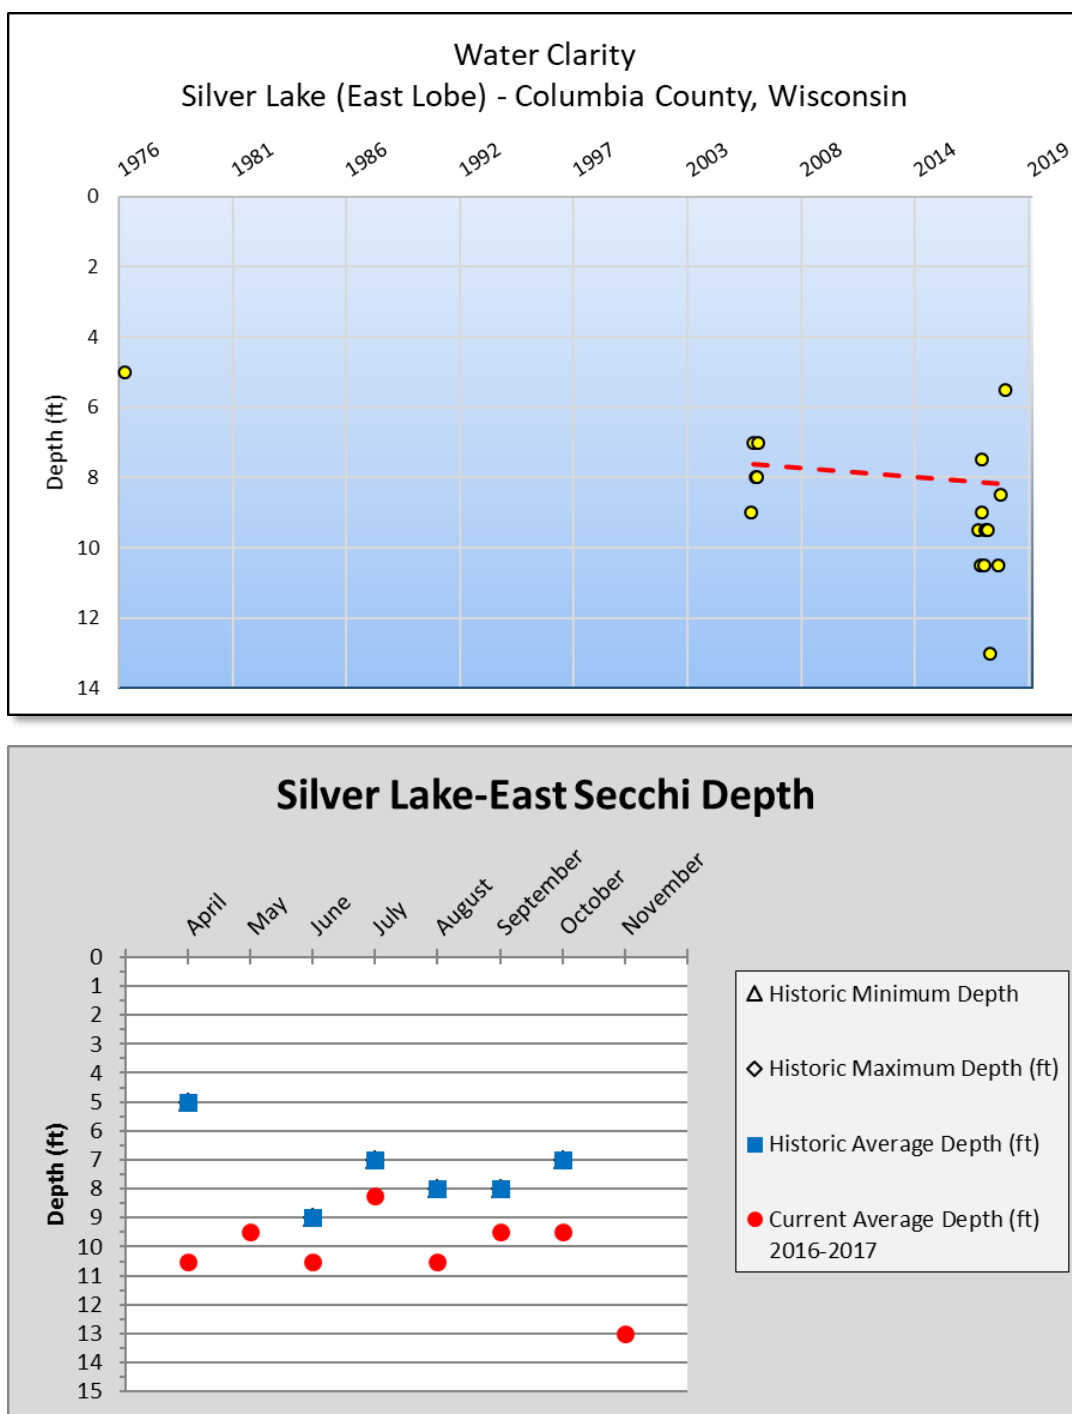
FIGURE 11. WATER CLARITY IN SILVER LAKE-EAST.

The east basin has a far more limited data set with only a few measurements prior to this study. Secchi depths ranged from 7 feet to 13 feet during the study (Figure 11). When compared with past data, the average water clarity measured during the study was better in all sampled months. Water clarity in Silver Lake was typically reduced during the late summer and early fall.
